REKORD 2.0 E

3.1983
(Replaces Ed. 1.1982)

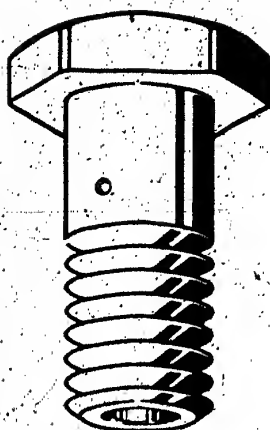
Fig. 1

Distributor-type fuel-injection pumps (VE) for Opel Kadett and Ascona Diesel are not fitted with overflow throttles (Fig. 1), but with overflow throttle fittings (Fig. 2 - Opel part).

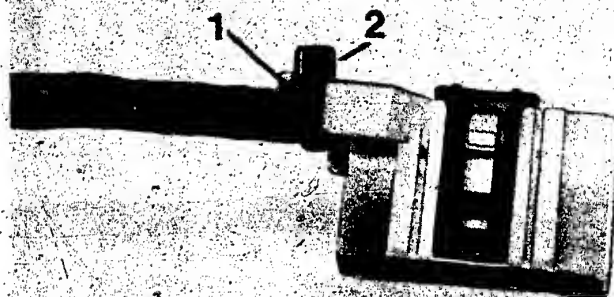
- 1 = Handle cover of trip computer plug (26-pin)
- 2 = Clamping band

When replacing trip computers 0 263 001 000/001, ..002/003, ..006/007 ..008/009, ..010/011, ..014/015 with versions ..022/023, the original Opel wiring harness must be converted as follows:

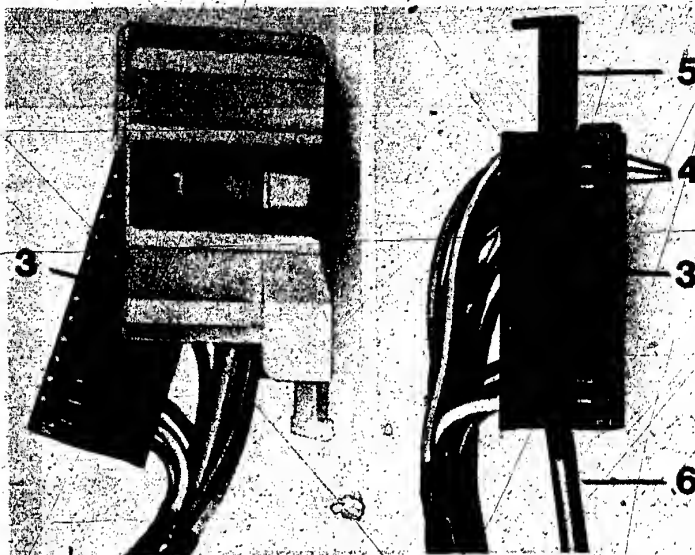
3 = Contact support 5 = Locking piece
4 = Minitimer 6 = Screwdriver

- Pull contact support (3) out of handle cover.
- Using a thin screwdriver (6), press locking piece (5) out of contact support (3).
- Insert code lead into trip computer plug in accordance with the following table (required as external wiring-harness coding for trip computers 0 263 001 022/023).

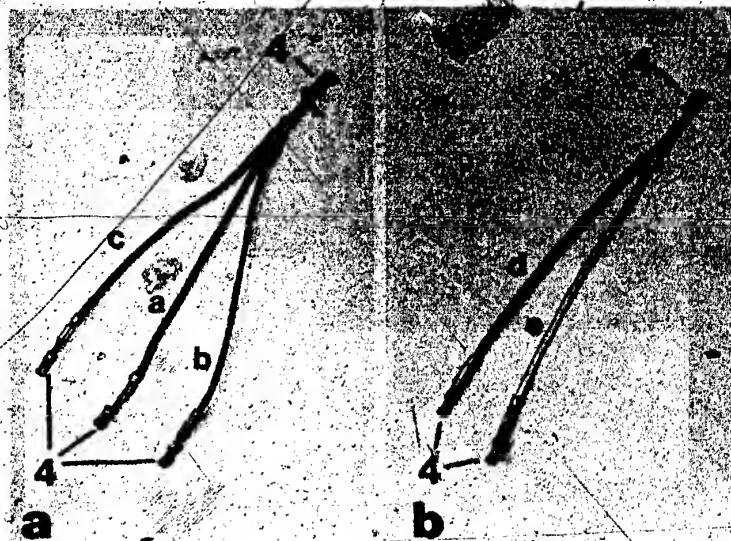
Fig. a = Code lead 1 Fig. b = Code lead 2

4 = Minitimer

2 code leads with attached minitimers are enclosed with the aftermarket versions of the trip computer. In addition, a new cover for the operator control panel (without illumination button) is enclosed. It can be changed after loosening 3 screws on the underside of the operator control panel.

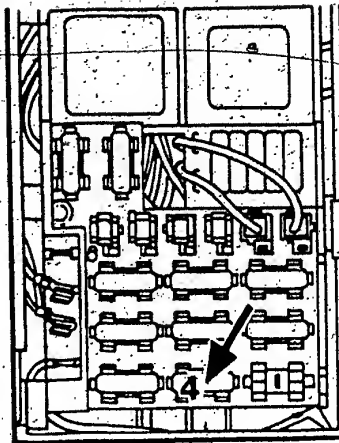
263/35

If point 4 is the cause of complaint (high temperature), full operational capability is resumed when the temperature drops below 65°C.

In none of the above cases is there any permanent damage to the trip computer.

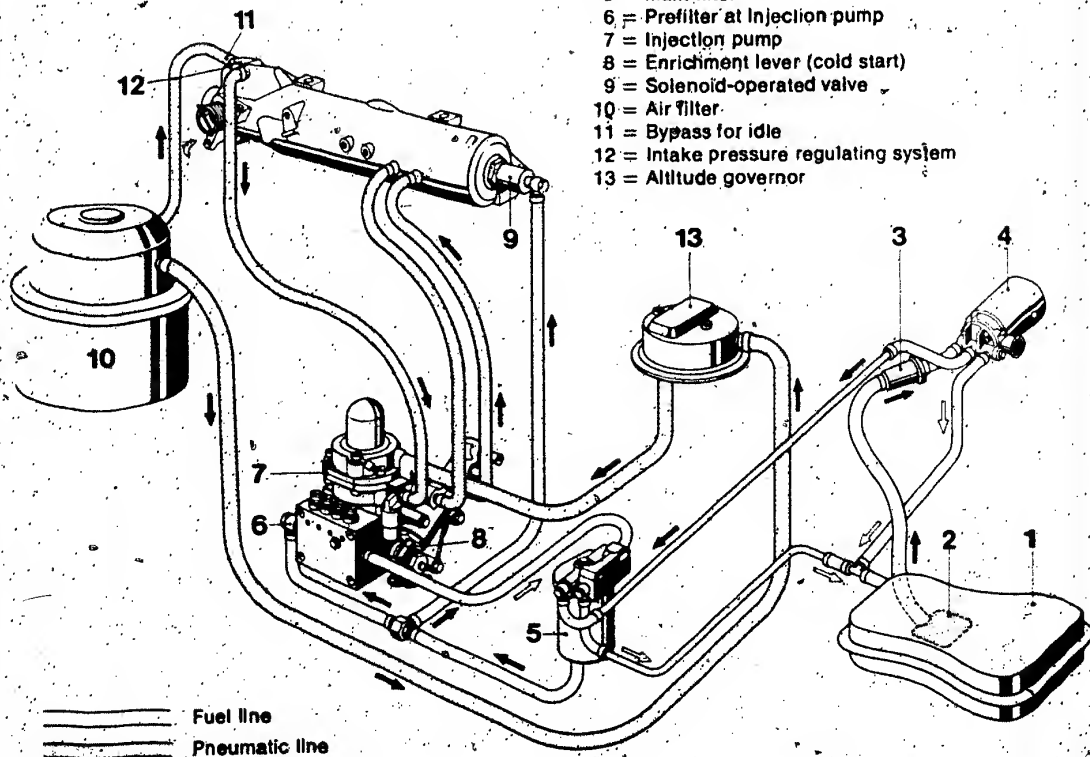
In order to ensure that exhaust gas regulations contained in the "Europe Test" can be met in the future, the cam lever in the A5 design of the injection pump was designed so that fuel injection is not cut off during overrun. In addition, the amount of fuel injected into the engine during idle was reduced. The cam lever has the designation A-006, 8 492 530 494. Contrary to the information given in the explanation of the pump type coding, the A5 and A6 designs cannot be replaced with designs A1 through A4. We recommend that as a basic rule you convert to the A5 or A6 design when a pump of design A1 through A4 must be repaired. In order to do this, the following changes must be made on the engine:

- 1 = Fuel tank
- 2 = Fuel intake strainer in fuel tank
- 3 = Prefilter at fuel supply pump
- 4 = Electric fuel supply pump
- 5 = Main filter
- 6 = Prefilter at Injection pump
- 7 = Injection pump
- 8 = Enrichment lever (cold start)
- 9 = Solenoid-operated valve
- 10 = Air filter
- 11 = Bypass for idle
- 12 = Intake pressure regulating system
- 13 = Altitude governor

- The diaphragm with a diameter of 2.3 mm (black) installed in the air distributor must be replaced by the diaphragm with a diameter of 2.2 mm (brass color), Part No. 8 491 102 220.
- The light gap in the throttle valve should be adjusted as described in the section "Adjusting the Pump to the Engine" below. After this adjustment has been made, the light gap should be enlarged by turning the idle stop screw $\frac{1}{8}$ of a turn inward. Set the idle speed and the CO concentration in the exhaust gases to the correct values.

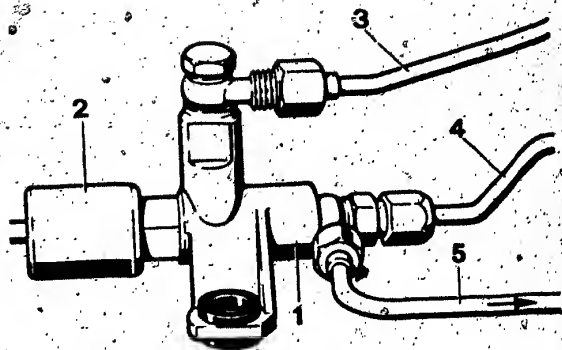
Fig. 2

Important note:

The effect of a possible fault in the control-pressure reduction system should be borne in mind when troubleshooting in the vehicle (control-pressure testing, leak test on the overall system).

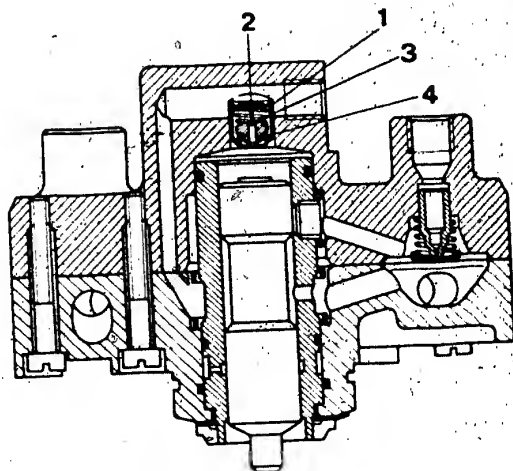
Fig. 3

The capsule valve contains a spring-loaded valve piston with restriction bore. The restriction bore has the same job as the previous non-adjustable flow control valve, namely that of damping the vibrations of the air-flow sensor plate as a result of pulsations in the air flow.

The enrichment of the air-fuel mixture necessary for acceleration is determined by the overshoot of the air-flow sensor plate and the resulting rise of the control plunger. The degree of overshoot is determined by the size of the restriction above the control plunger. In the case of rapid acceleration the valve piston in the capsule valve is lifted, thus resulting in a faster displacement of the fuel over the control plunger. This optimizes the transition response of the engine. The valve piston remains closed under slow acceleration and in all other engine operating conditions.

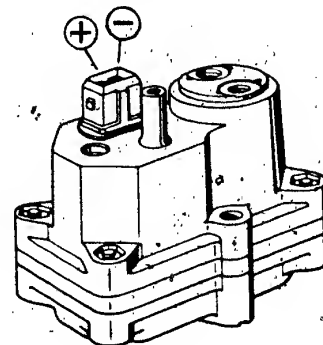
Fig. 6

In the case of warm-up regulators with a thermo-contact it is absolutely essential to ensure the correct polarity of the electric connector. Incorrect connection will cause irreparable damage to the thermo-contact.

On the 928/928 S vehicles of model years 1978 to 1980 the correct polarity is not specified. Therefore, this must be tested when installing the new warm-up regulators and must, if necessary, be corrected on the connector (+ to +, - to -).

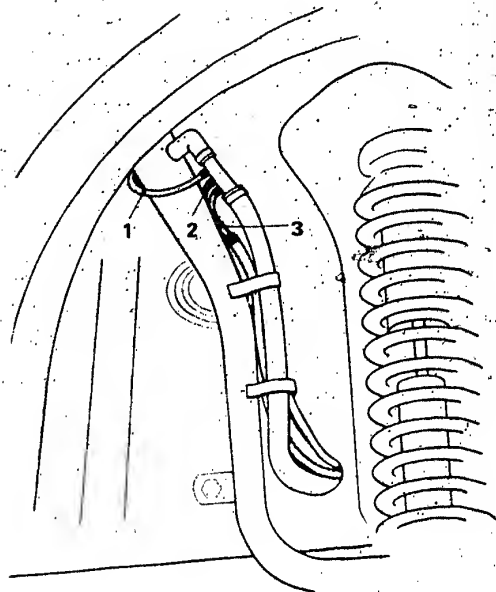
In these vehicles it can occur that the control plunger in the fuel distributor jams, due to corrosion or dirt. The result: starting troubles.

This problem can be caused by the fuel-tank-ventilation hoses not having been laid correctly: the hoses can be gradually worn through due to rubbing against the rear wheel. This allows dirt and salt water to be sucked into the fuel tank.

Hose 1 must be laid as short as possible, but without tension. Lay hoses 2 and 3 between the fuel-tank filler fitting and the side of the bodywork. Shorten them if necessary.

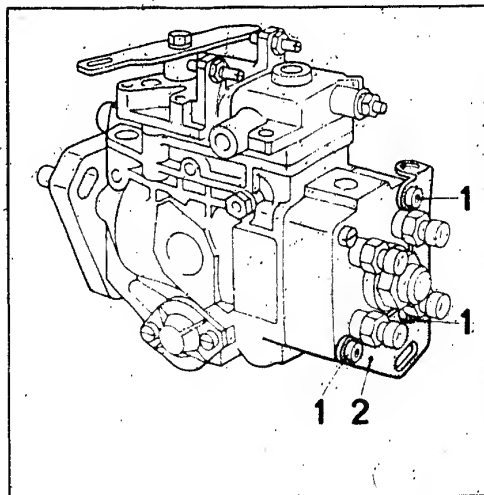
Fig. 2

It has become necessary for us point out that the fastening screws (Fig. 2, Pos. 1), are not to be loosened or removed when the pump is removed. These screws serve to fasten the hydraulic head. Loosening or removal can cause the pump plunger to tilt, and this can result in plunger breakage.

The same number of shims must be fitted under the support plate (Fig. 2, Pos. 2) for each of the 3 hexagon-socket-head cap screws (Fig. 2, Pos. 1).

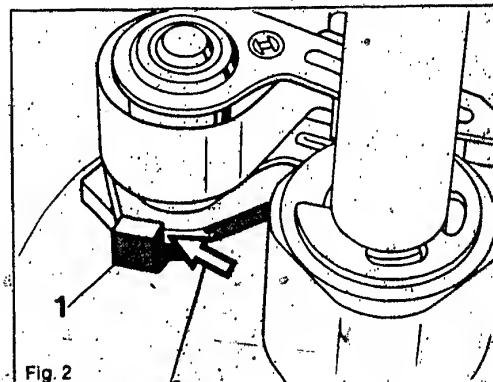
Fig. 2

If the bearing pin has slipped correctly into place the contact support will come to rest at the specially provided stop bracket (Fig. 2).

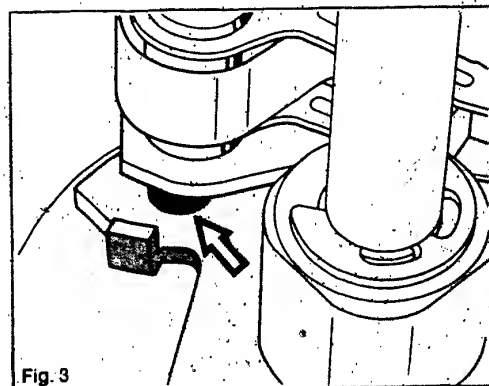
In Fig. 3 (arrow) the bearing pin has not slipped in. Carry out a visual check.

Mount the ignition distributor correctly and carry out the necessary adjustments. Put the closing cover back on. (Be sure of perfect fitting.)
